ATSB TRANSPORT SAFETY INVESTIGATION REPORT  
Marine Occurrence Investigation No. 238  
Final

Independent investigation into the boiler explosions  
on board the Panamanian registered bulk carrier

# Shirane

2 April 2007

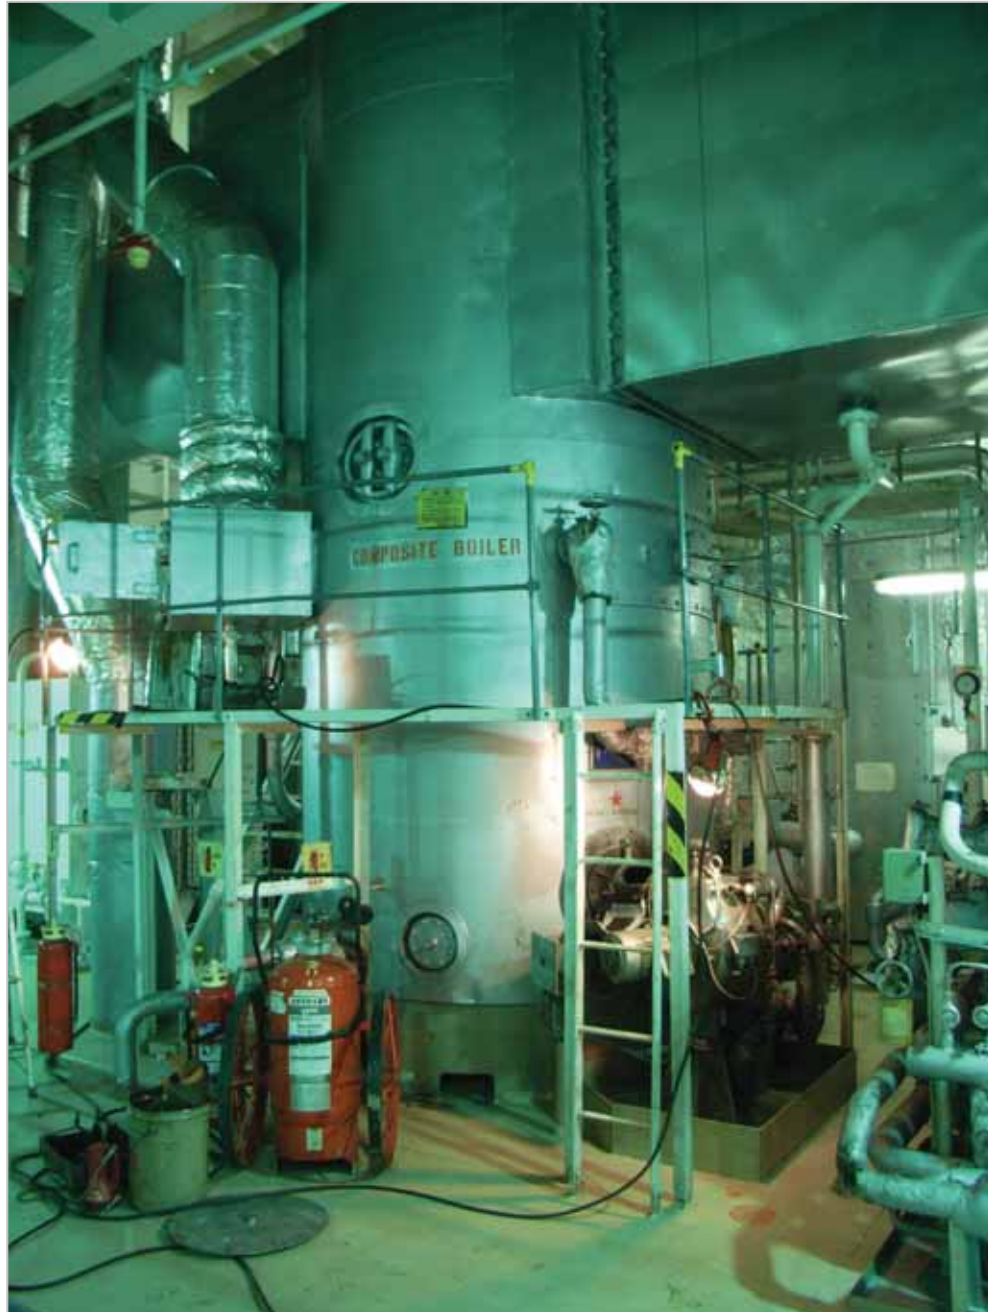
**Figure 2:** *Shirane's* composite boiler

*Shirane* is fitted with an Osaka Boiler Mfg Company OEVC2-120/120-20 vertical composite boiler (Figures 2 and 3). The boiler has a working pressure of 6.0 bar<sup>3</sup> and uses main engine exhaust gases and/or a packaged oil firing unit to produce steam. Steam is used on board the ship to heat fuel, for treatment before its use in the main and auxiliary engines, and for general heating purposes.

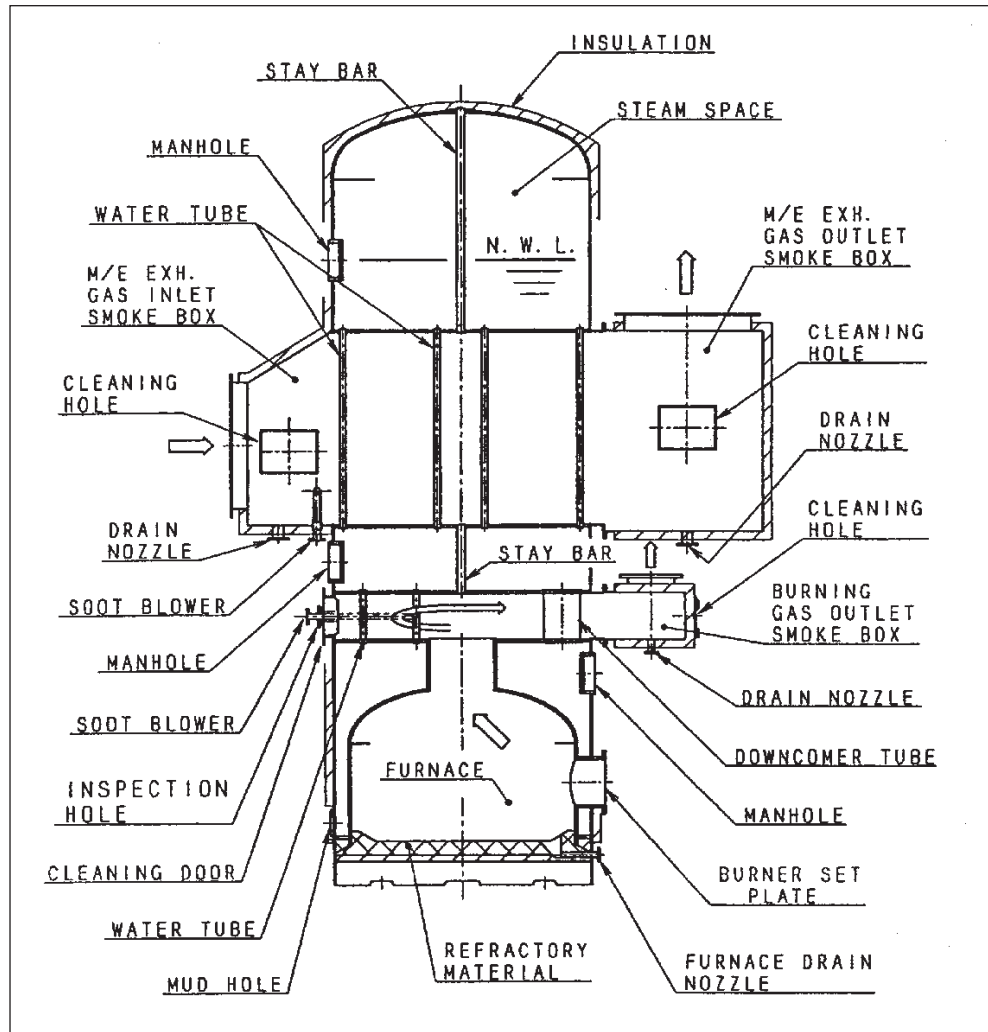
**Figure 3: Schematic diagram of boiler**

The upper section of the boiler water space houses the economiser part of the boiler (Figure 3). In this section, the main engine exhaust gases are directed over a bank of water tubes. Beneath the economiser section is the smoke box, which has a hot gas inlet from the furnace, another bank of boiler water tubes and an exhaust gas outlet.

The truncated hemispherical steel furnace lies below the smoke box. The furnace chamber has a single oil firing unit opening at one side. When the burner is firing, the flame is directed at the furnace wall opposite the burner opening with the flow of hot gas sweeping the periphery of the cylindrical furnace chamber before rising to the smoke box inlet.

Many auxiliary boiler designs have a water space around the entire furnace that acts to cool the furnace. However, this is not the case with the Osaka OECV2 boiler. While the top part of the furnace is water cooled, the furnace floor is not. Furthermore, the floor is lined with refractory material which cools relatively slowly after the boiler has been firing.

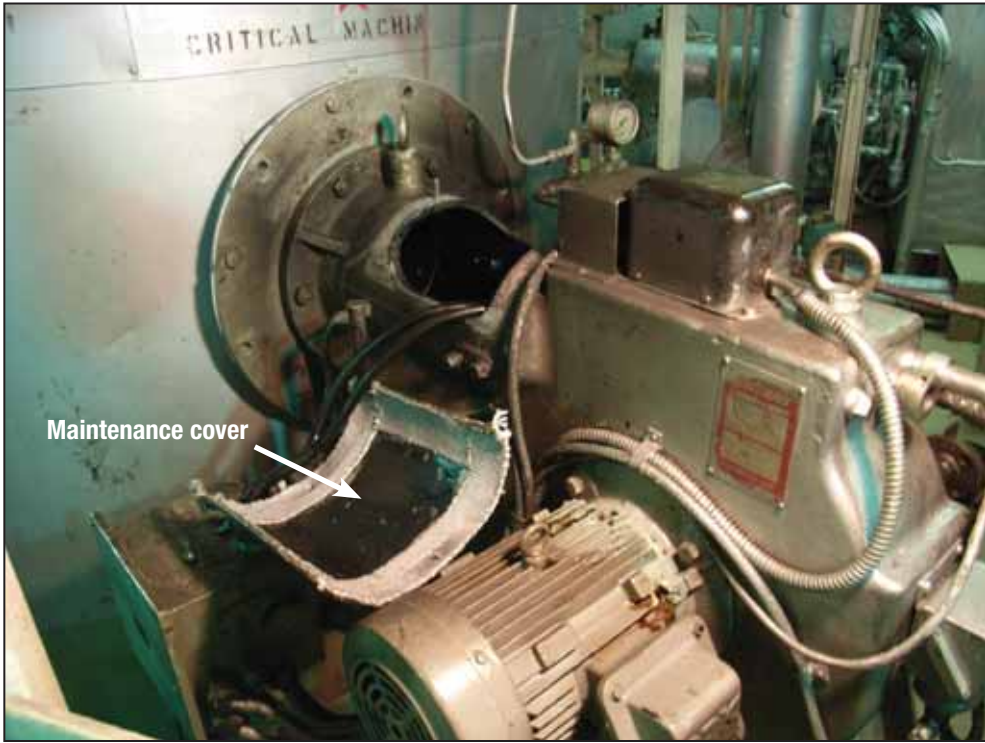
**Figure 4: Volcano VJ-140-1 oil firing unit**

When the ship's main engine is stopped, or is providing insufficient exhaust gas energy to produce enough steam to meet the demand, the boiler is fired using oil. The oil firing unit, a VJ-140-1, was manufactured by the Volcano Company of Japan (Figure 4). The unit comprises a fully automatic pressure jet oil burner, integrated with a single electric motor driving both the forced draft fan and the fuel oil feed pump. Control of combustion air flow is provided by a single, two-position, damper on the forced draft fan's air inlet housing. The oil firing unit may be fired using either diesel or heavy fuel and has an integrated electric heater for use when firing on heavy fuel. The oil firing unit's controls and monitoring system are located in a cabinet which is mounted on a bulkhead adjacent to the boiler.

*Shirane's* boiler was not equipped with a quick method of safely sighting the furnace floor. Therefore, there was no easy way to gauge when it was necessary to allow the furnace to cool before opening the oil firing unit maintenance cover. The only way to sight the furnace floor was to remove the burner and then look down the oil firing unit flame funnel.

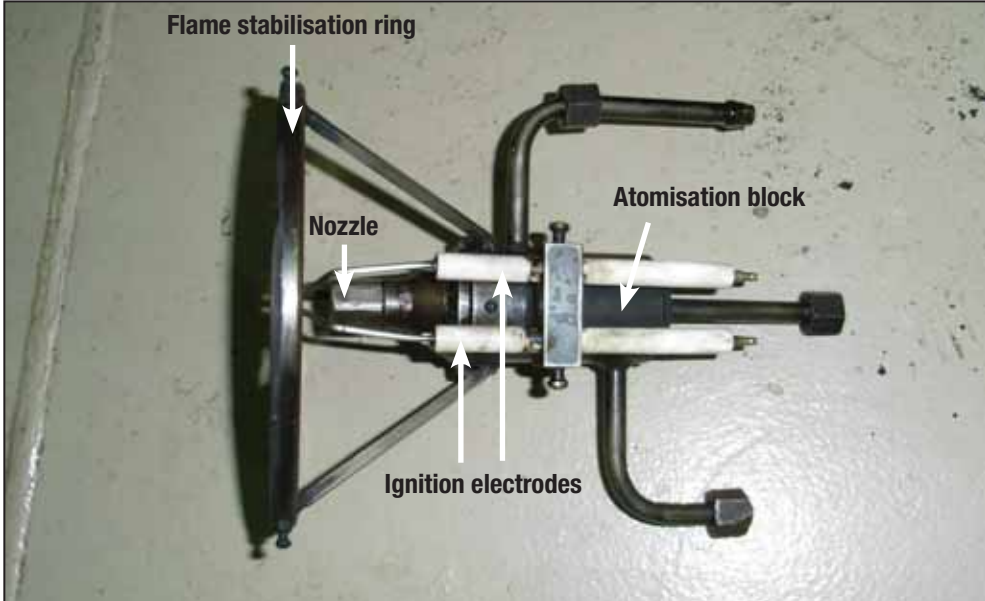
**Figure 5: Oil firing unit burner**

The burner (Figure 5) is fitted inside the oil firing unit at the boiler furnace opening. The burner consists of an atomiser block, which holds a single fuel nozzle, to which a flame stabilisation ring and a pair of ignition electrodes are attached. The atomiser block has three fuel line connections; one line is led from an electric solenoid valve which supplies the fuel nozzle, and the two other lines allow fuel circulation through the atomiser block. The burner may be removed from the oil firing unit through a maintenance cover at the top of the unit, after the ignition electrode cables and the three fuel pipes have been disconnected.

It was not unusual for *Shirane's* boiler to misfire due to a build-up of carbon on the flame stabilisation ring. Consequently, during periods when the boiler was operating, it was normal practice for the burner to be exchanged with a clean replacement unit every few days.

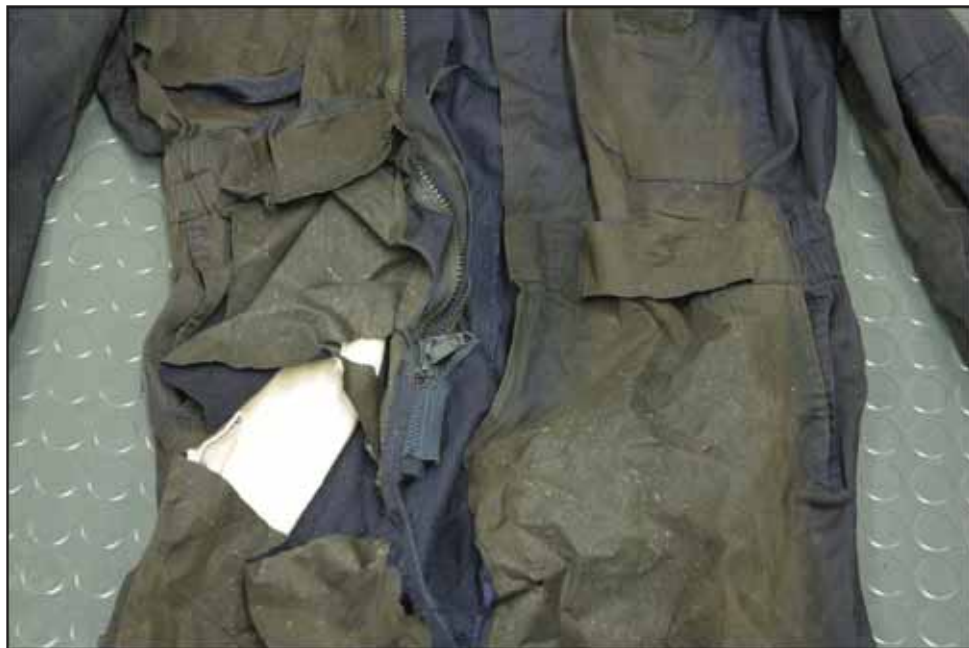
**Figure 6: The third engineer's polyester/viscose overalls**

When the third engineer's overalls were hit by the flames from the furnace flashback, the central zipper melted and the overall material ignited (Figure 6). The overalls had provided inadequate protection to the third engineer and, as a result, he sustained burn injuries to his stomach.

Neither the synthetic overalls nor the cotton overalls provided the engineers with the protection they needed. Therefore, they were not appropriate for the task.
